The Conservancy Association

RE: Comment on Housing Sites in Yuen Long South EIA Report

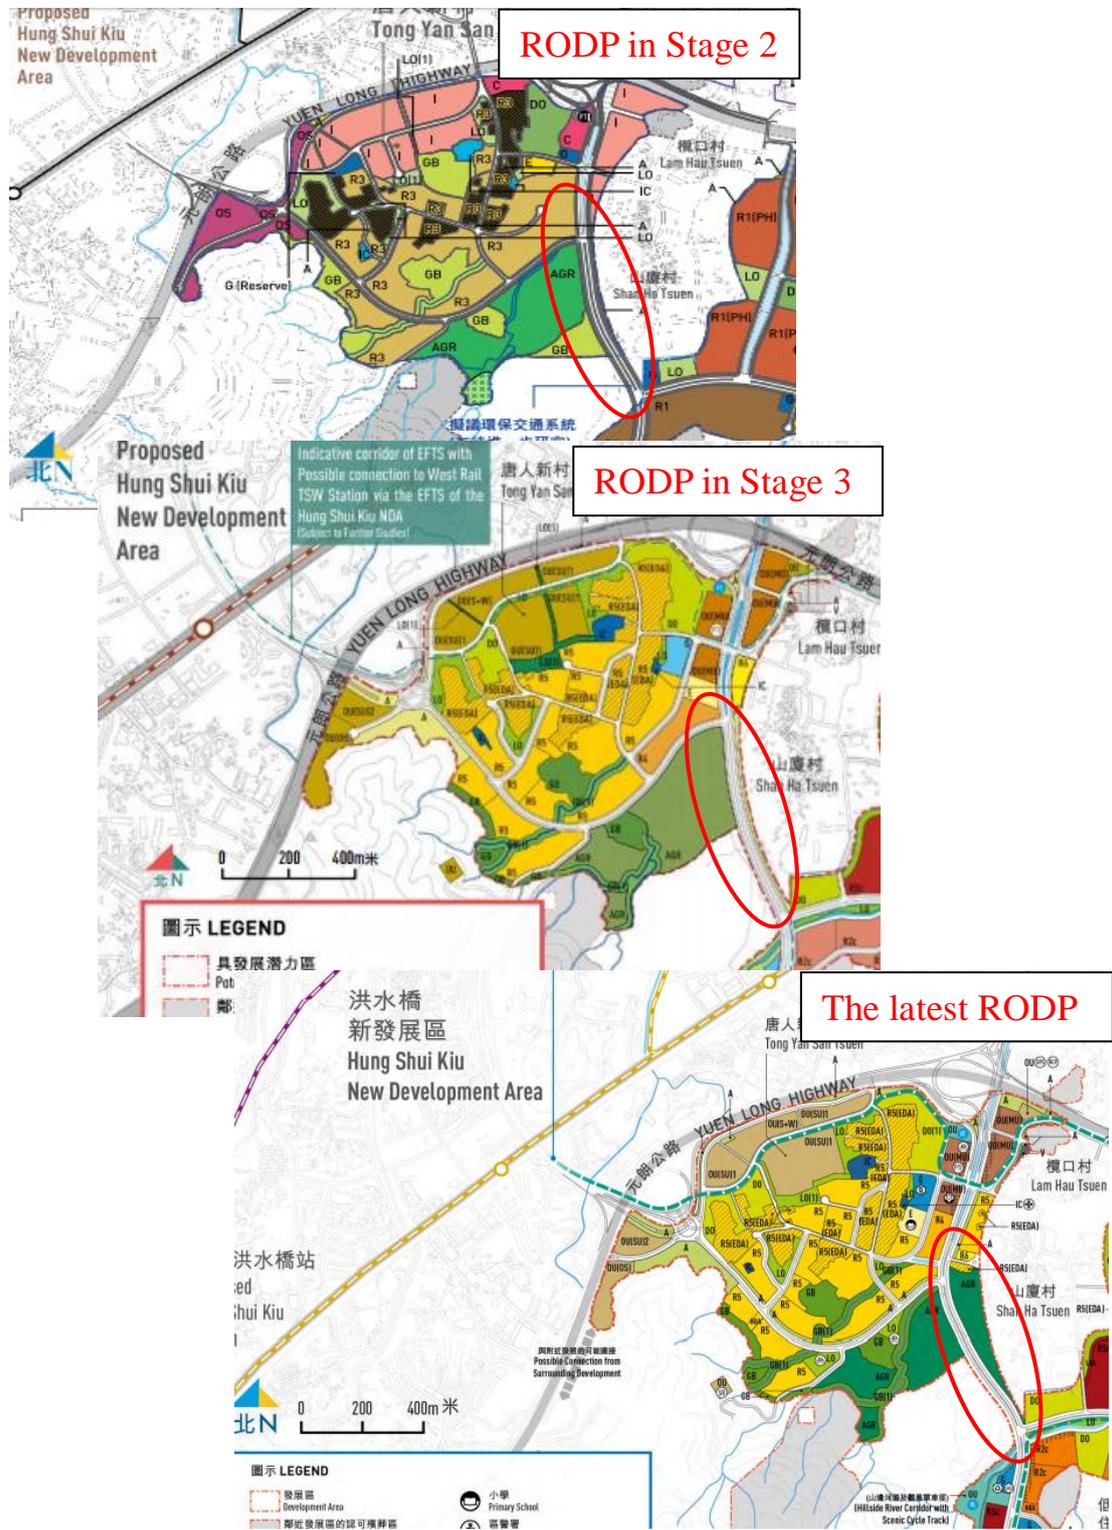
Figure 1 RODPs in the previous 2 stages of public consultation reveals that the alignment of Road D1 (circled in red) lies at the eastern periphery of the agricultural land (AGR zone) in Shan Ha Tsuen. The current alignment would cut the AGR zone and cause fragmentation of the agricultural land.

The latest Recommended Outline Development Plan (RODP) has realigned Road D1 (Figure 1) and then caused fragmentation of the agricultural land at Shan Ha Tsuen. The EIA report stated that measures have been adopted to minimize ecological impact, such as adjusting the road to the eastern limit of the agricultural land, reducing width of footpath and amenity area<sup>1</sup>. CA worries that it would not only result in direct loss of wet and dry agricultural land, but also change the hydrology, and even ecological condition of the entire agricultural area. However, alternatives of the road alignment and design have not been assessed and we wonder if fragmentation of the agricultural land can be further minimized or even avoided.
