The Conservancy Association

RE: Comments on San Tin/Lok Ma Chau Development Node Project Profile

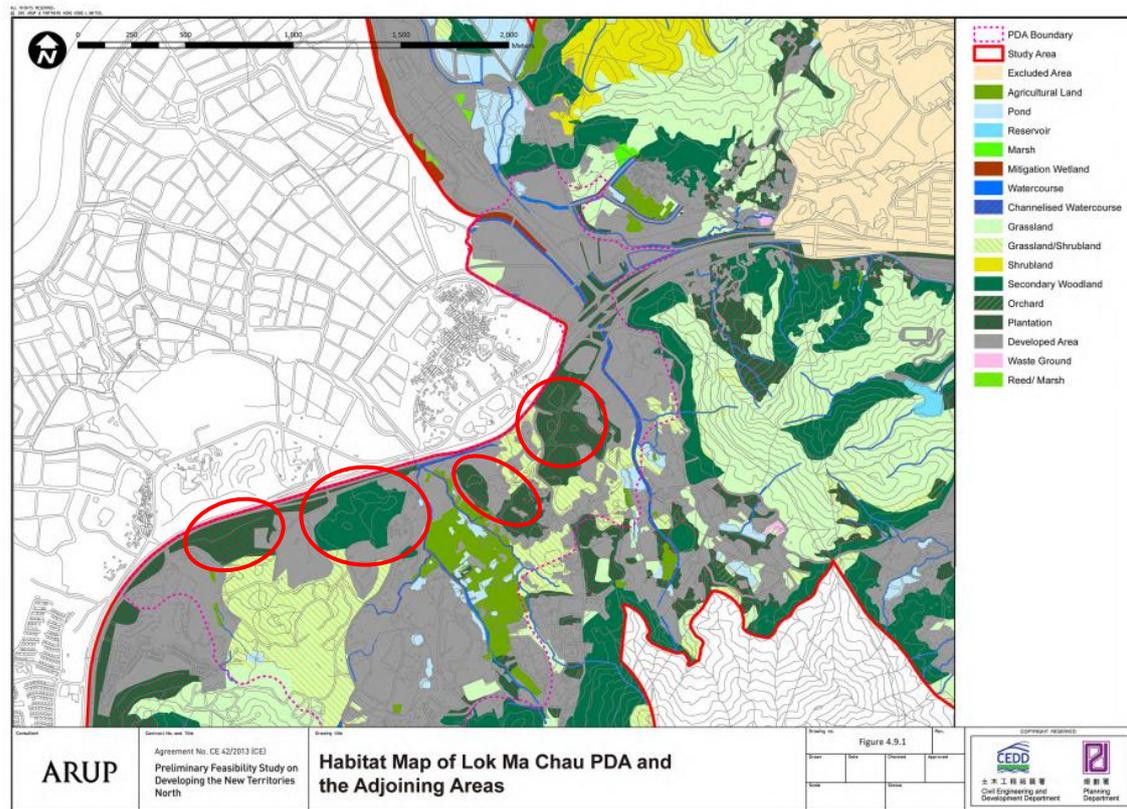
Figure 1 Some secondary woodland and plantation (circled in red) can be spotted in the project site

If comparing the past habitat map¹ (Figure 1) with the preliminary outline development plan of San Tin/Lok Ma Chau Potential Development Area², some proposed development use would encroach existing secondary woodland and plantation. Although conditions of these wooded clusters have to be further evaluated during the EIA process, we are doubtful if the current land use is the most appropriate option in avoiding woodland loss. Provision of tree compensatory proposal, to a certain extent, would help preserve individuals but may not re-create an equivalent ecological value and integrity of a habitat.

- i. The project proponent should further explore ways to avoid/minimize direct loss on the above habitat and all other ecologically sensitive wooded areas in both construction and operation phase.
